LAKE HAUTO DAM

NDS No. PA-00606

PHASE I INSPECTION REPORT NATIONAL DAM INSPECTION PROGRAM

Berger Associates, Inc.
Harrisburg, Pennsylvania
FEBRUARY 1979

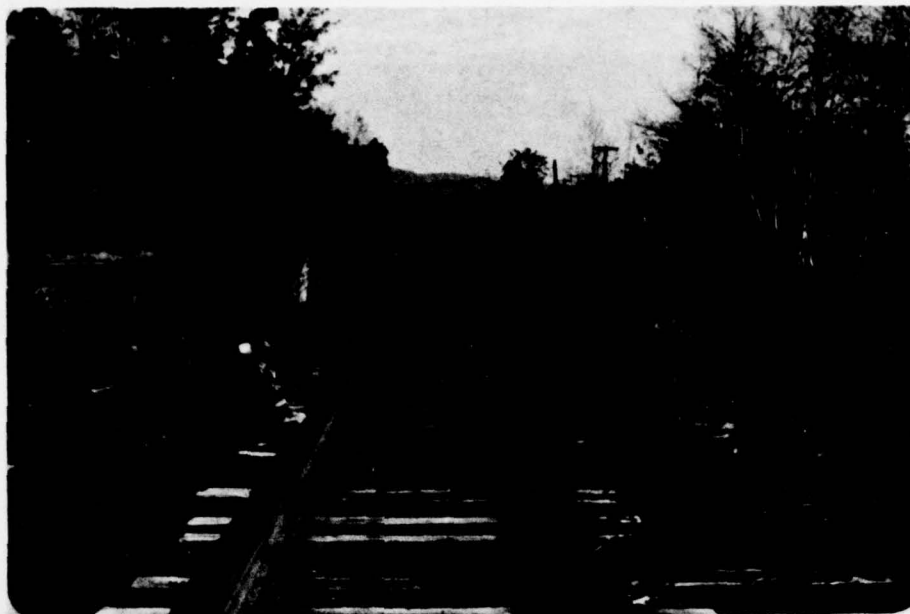
The visual inspection, the review of available design data and the operational history indicates that Lake Hauto Dam is in good condition and has been designed in accordance with acceptable engineering practice. The main concern is the adequacy of embankment protection at the emergency spillway location.

Emergency Spillway
With Railroad

Additional studies should be made by a qualified professional engineer after cleaning the area of the emergency spillway to evaluate the adequacy of existing protection of the embankment. An analysis, based on an accurate survey, should determine the concentration, depth of water and flow velocity of the water discharge in that area. This engineering analysis should include recommendations for preventing erosion of the embankment during flow through the emergency spillway.

1. It is recommended that the owner engage a qualified professional engineer to evaluate the adequacy of the embankment protection at the emergency spillway and construct necessary improvements proposed by the engineer.
